**STILWELL LAKE DAM
ORANGE COUNTY, NEW YORK
INVENTORY NO. 770**

**PHASE I INSPECTION REPORT
NATIONAL DAM SAFETY PROGRAM**

NEW YORK DISTRICT CORPS OF ENGINEERS

DECEMBER 1978

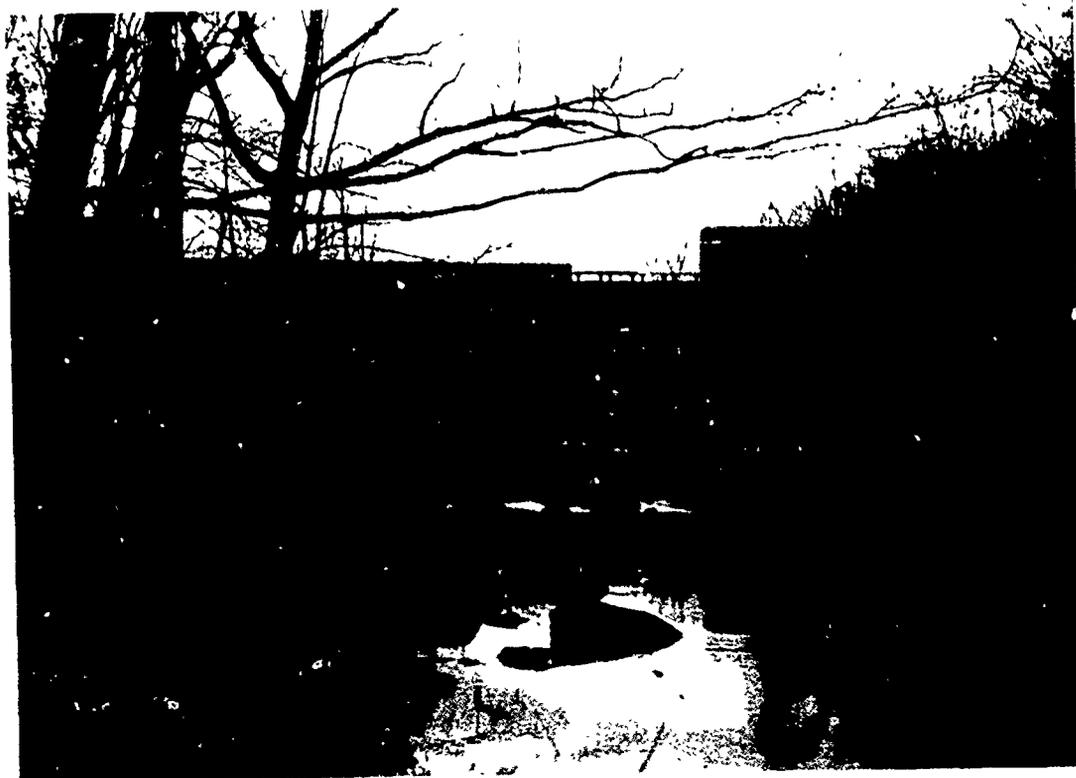
9. OVERALL VIEW OF DOWNSTREAM CHANNEL

a. Condition (obstructions, debris, etc.) There is no concrete apron beyond the dam. The stream bed is full of rocks and stones. Some debris existed but constitute no obstruction. There are a line of trees along o/s face of right non-overflow monoliths.
